## Wisper CMS/ Wisper On-premises Case Study

### A Stainless-Steel Coil Manufacturer

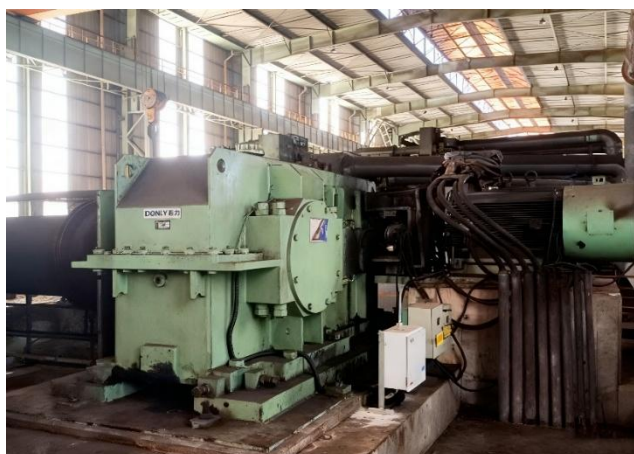
9 measurement points across the tension roller's:

- Motor drive end
- Motor non-drive end
- First shaft input & output end
- Second shaft input end
- Third shaft output end
- Fourth shaft input end
- Fifth shaft input & output end

*A picture of the tension roller*
